Garland Mineral Springs

Flood Damage Timeline – 2025 to Present

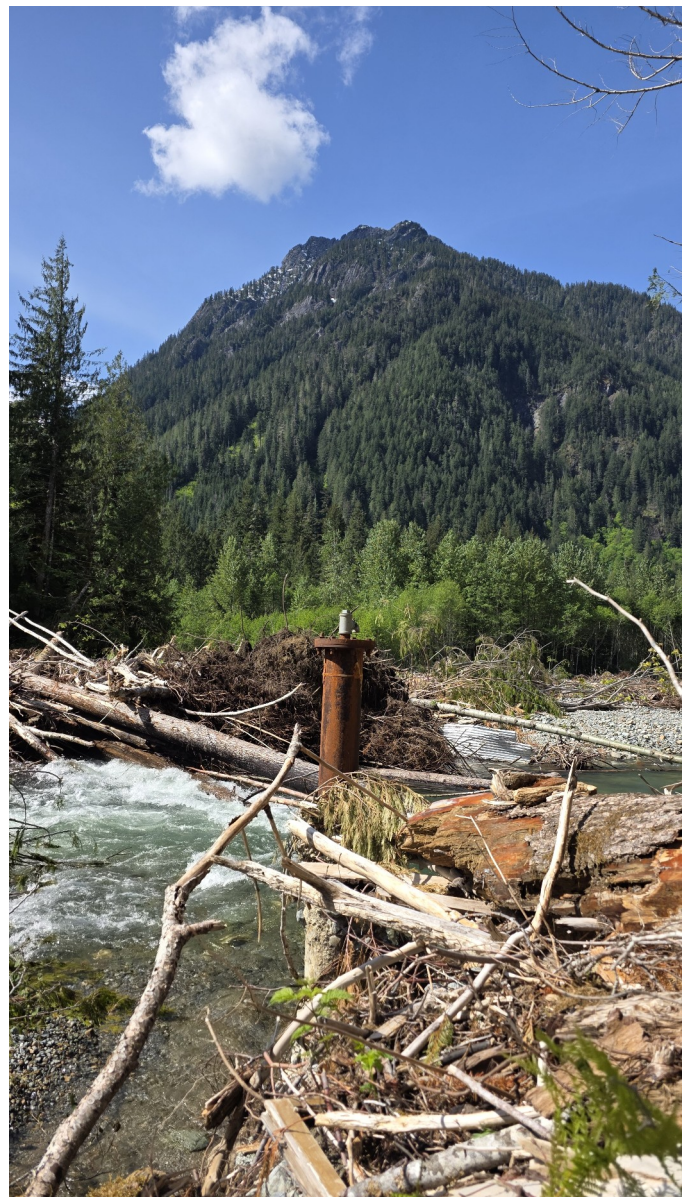
Figure 1: Geothermal exploration well drilled by Snohomish County PUD in 2011. Prior to the 2025 flood, the well was located within a forested area adjacent to historic cabins. Today, river migration has swept over the mineral springs and left the wellhead exposed within the active flood channel.

Geothermal exploration wells drilled in 2011 to evaluate the underground hot water resource are now located dangerously close to active river channels created or expanded during the flooding events.

Continued erosion and channel migration may place portions of the geothermal infrastructure “in the river” if stabilization measures are not undertaken.
